**Coal Combustion Waste Impoundment  
Round 7 - Dam Assessment Report**

*Sioux Power Station*

*Ameren Missouri*  
**St. Charles County, Missouri**

**December 2011**

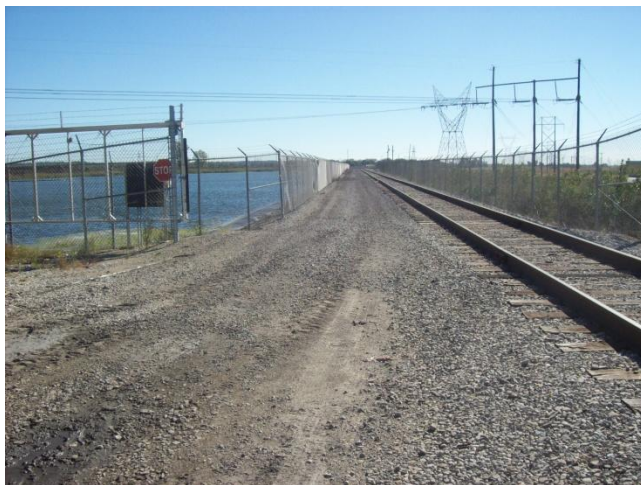
The southern embankment crest is much narrower in width, approximately 30 feet, than the western crest, and also contains a railroad bed that is used by the plant operators two to three times during the week (Fig. 5.2.1-2).

Figure 5.2.1-2: Photograph of Fly Ash Embankment, View to the East

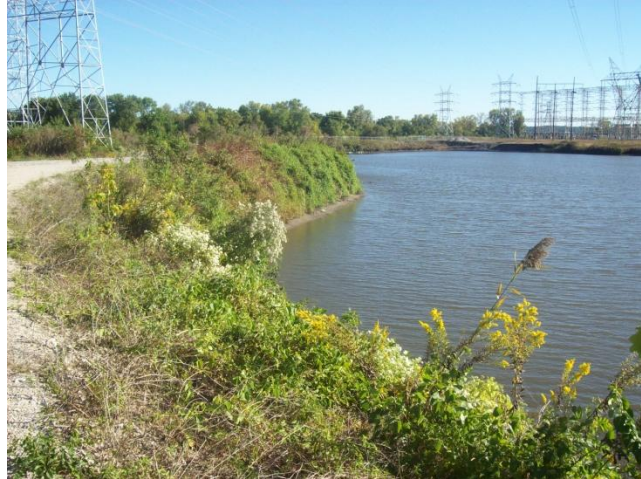
The upstream/inside slope is vegetated with various scrub/shrub species and tall grasses and wildflowers. There were no observed scarps, sloughs, bulging, cracks, depressions, or other signs of slope instability. Rip-rap had been placed along the interior slopes of the northern and northwestern portions of the embankment to enhance stability.

Figure 5.3.2-2: Photograph of Bottom Ash Pond Upstream/Inside Slope, View looking North

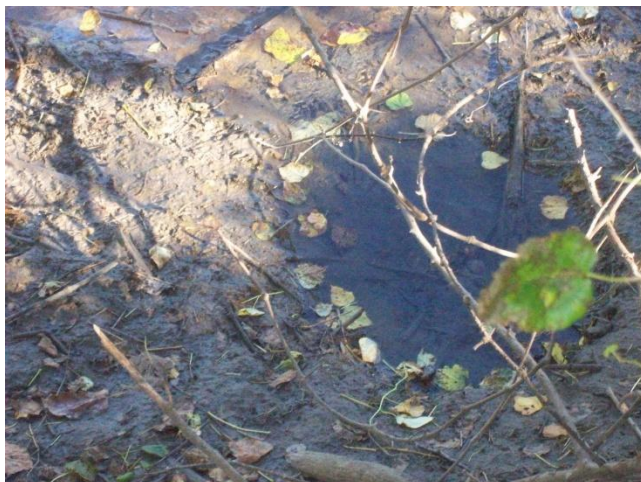
A small seep was observed (Fig. 5.3.3-2) in the northeastern corner of the pond embankment, approximately 75' from the toe of the embankment. The situation is monitored weekly by Ameren Missouri personnel.

Figure 5.3.3-2: Photograph of clearwater seep emerging 75' from toe of embankment.

**5.3.3 Downstream/Outside Slope and Toe: A small seep was observed (Fig. 5.3.3-2) in the northwestern corner of the pond embankment, approximately 75' from the toe of the embankment.**

Ameren Missouri has initiated a project to install an inverted filter along the seepage area, and is projected to be implemented in 2011.

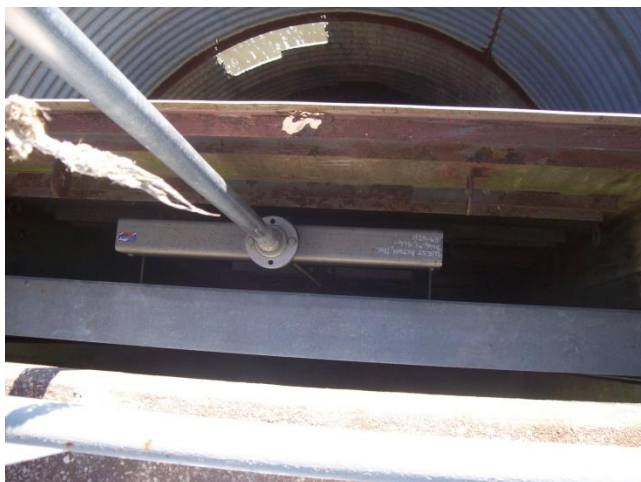
The Bottom Ash Pond has a concrete pit where pond water drains before discharging via a 30-inch concrete pipe. The outfall structure comprises of a 24-inch HPDE pipe with a suction bell below the water surface and a large diameter galvanized corrugated steel skimmer to allow water to flow into the concrete pit (Fig 5.4.1-1). A portion of the corrugated steel skimmer was removed to allow additional flow to enter the structure.

Figure 5.4.1-1: Emergency isolation gate system for flow control for the Bottom Ash Pond.

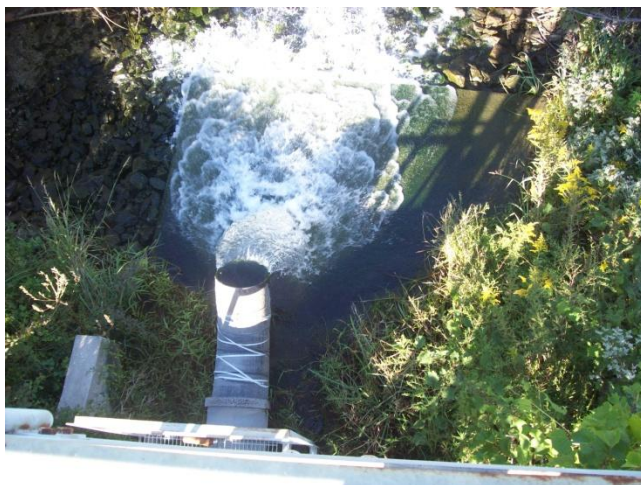
The Fly Ash Pond outfalls to Poeling Lake via an 18" HDPE pipe. The outlet conduit appeared to be in good shape and operating normally with no signs of clogging. Water discharging from the pipe appeared to be clear.

Figure 5.4.2-1: Photograph of Fly Ash Pond outfall (18" HDPE pipe) and stilling basin, Looking West

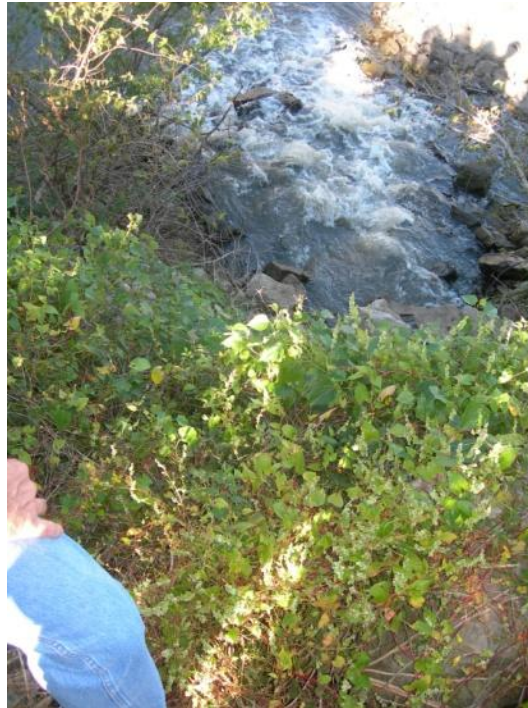
The 30-inch concrete pipe outlet conduit for the Bottom Ash Pond appeared to be in good shape and operating normally with no signs of clogging. Water discharging from the pipe appeared to be clear.

Figure 5.4.2-2: Photograph of Bottom Ash Pond outfall, Looking West

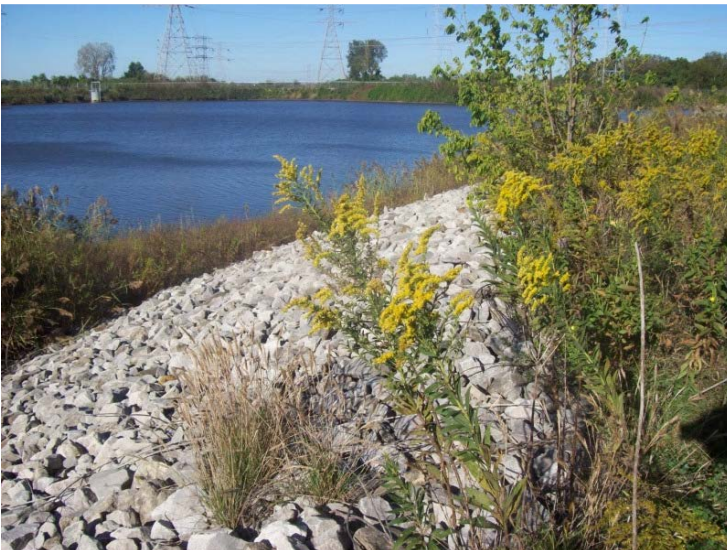
**5. Looking at interior lined riprap slope problem.**

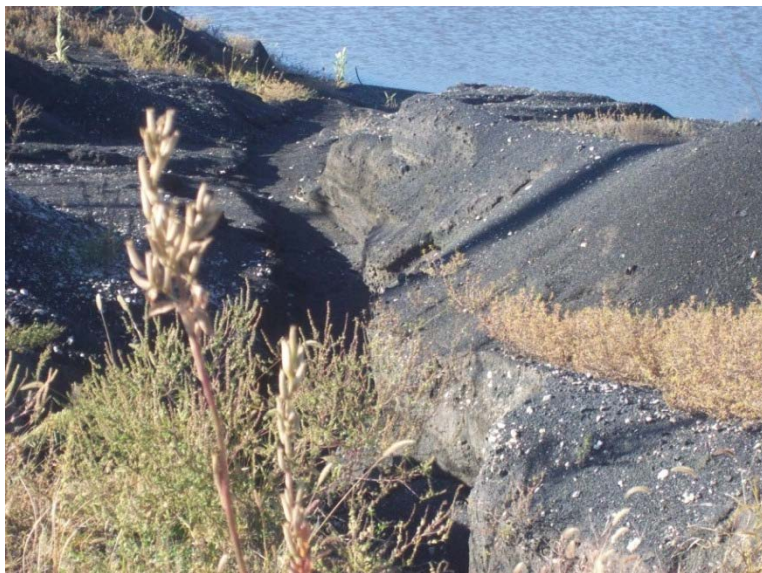
**8. Runoff erosion in Bottom Ash Pond.**

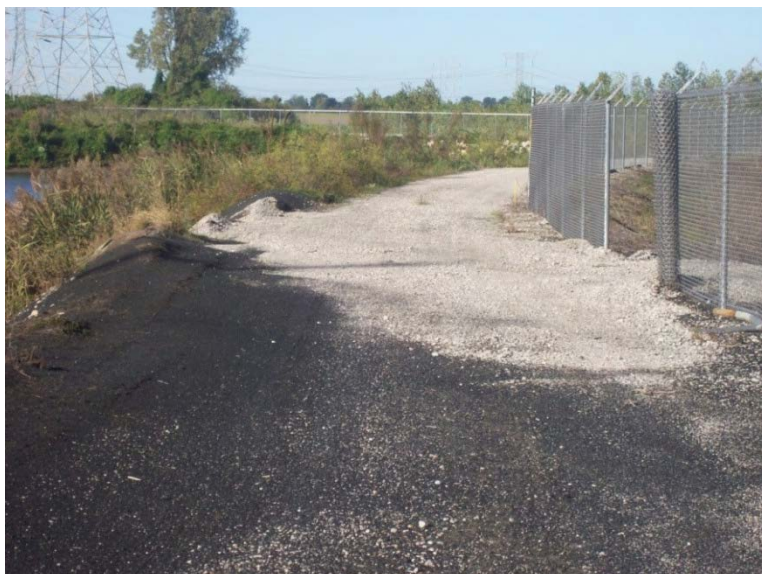
**9. Top of embankment looking West.  
Note - Bottom Ash along embankment.**

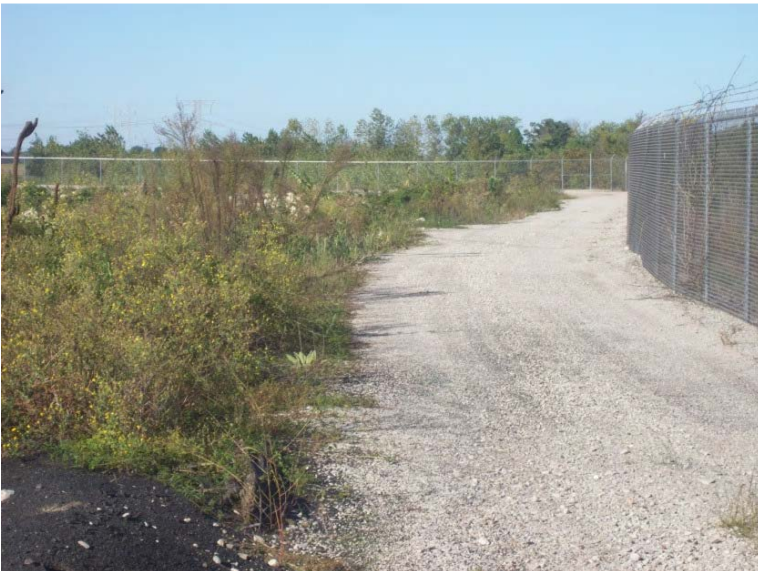
**10. Looking West along embankment.  
Note – heavy vegetation along inside slope of embankment.**

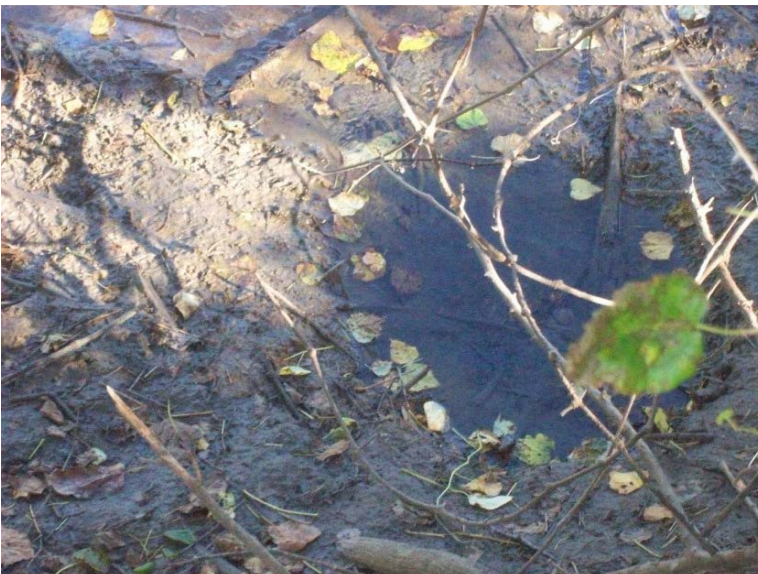
**11. Seep location approximately 75' from toe of embankment and flows to the Mississippi River. Note – seep water is clear and being monitored by weekly inspection team.**

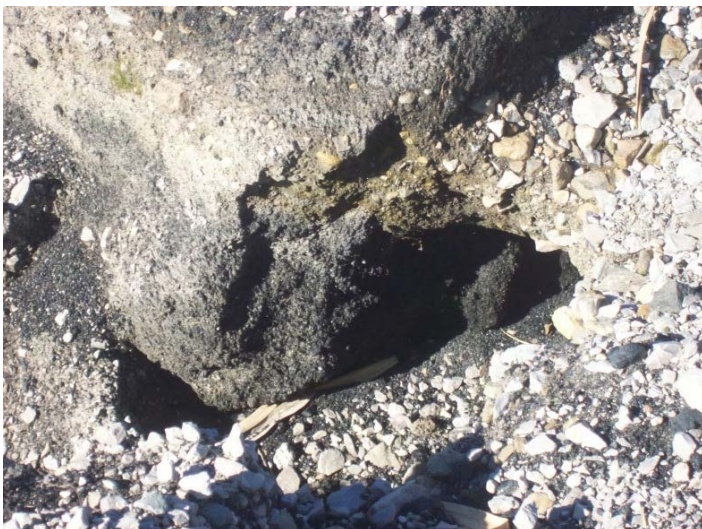
**14. Erosion area by riprap. Note - material looks like bottom ash.**

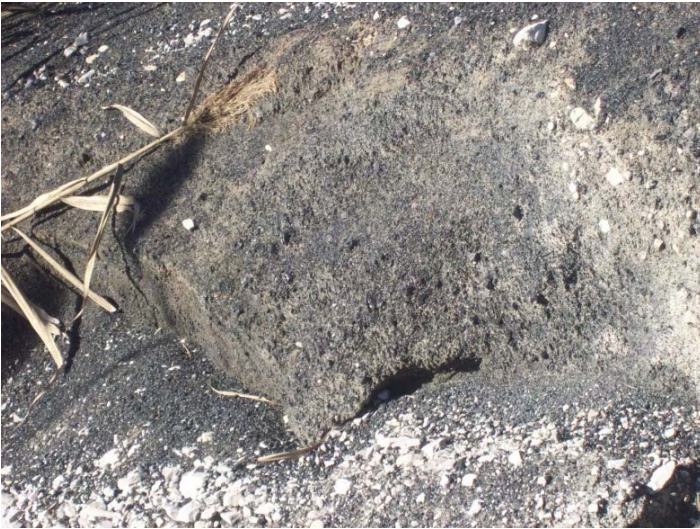
**15. Erosion area by riprap. Note - material looks like bottom ash.**

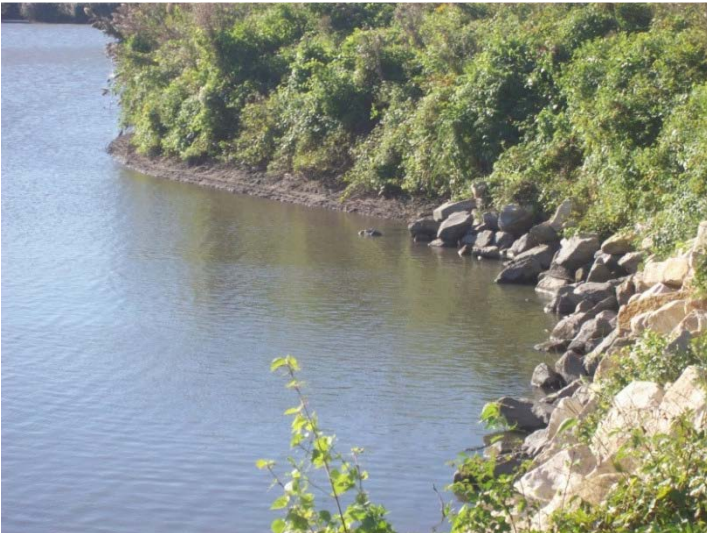
**16. Looking West where the riprap slope problem stops. Note - vegetation along bank.**

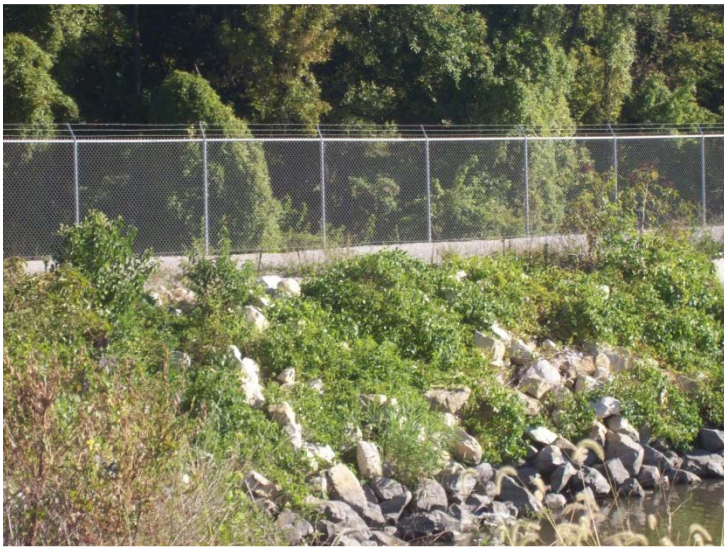
**18. Looking at North side of Bottom Ash Pond. Note - vegetation and riprap.**

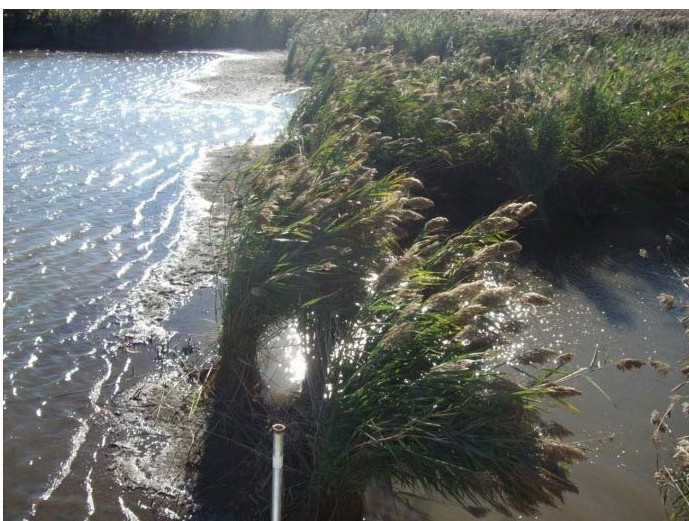
**26. Note - wave action along bank.**

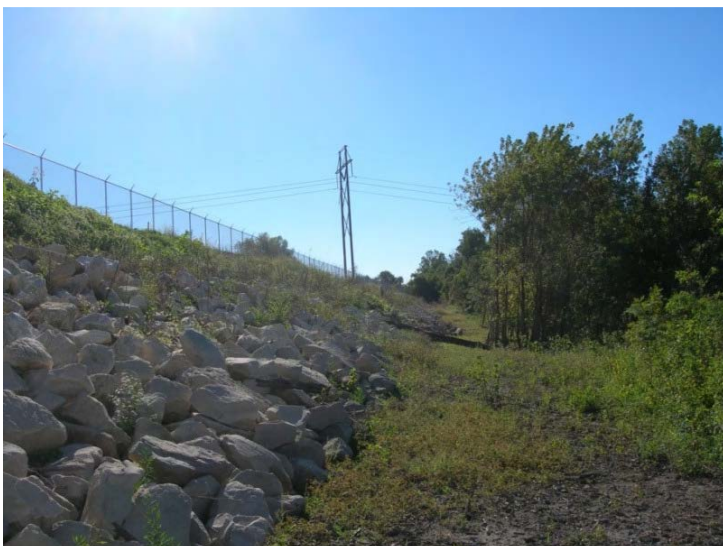
**28A. Looking Southeast along toe of embankment. Riprap placed after major tree removal activity.**

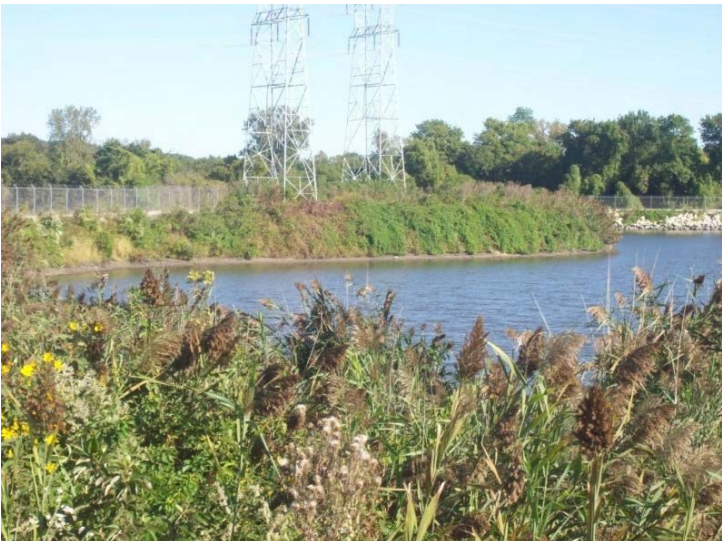
**30. Looking North across Bottom Ash Pond at the wider top width section along East side of pond.**

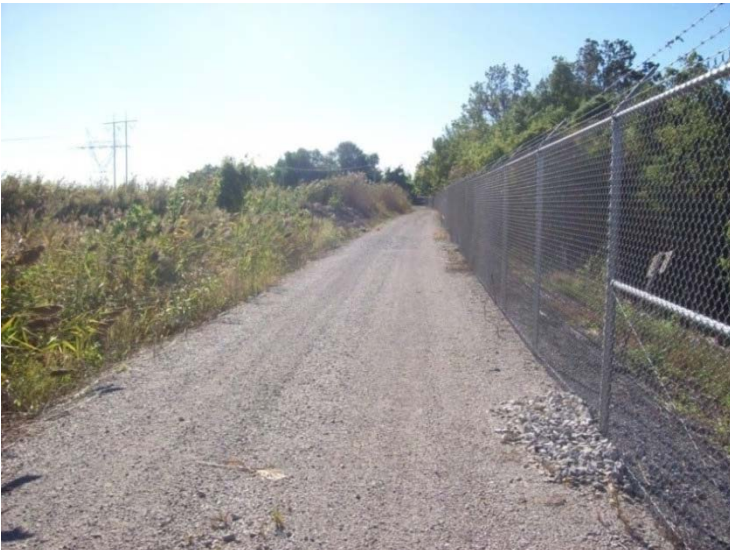
**33. Looking Southeast along top of embankment. Note - some maintenance area to reduce runoff erosion.**

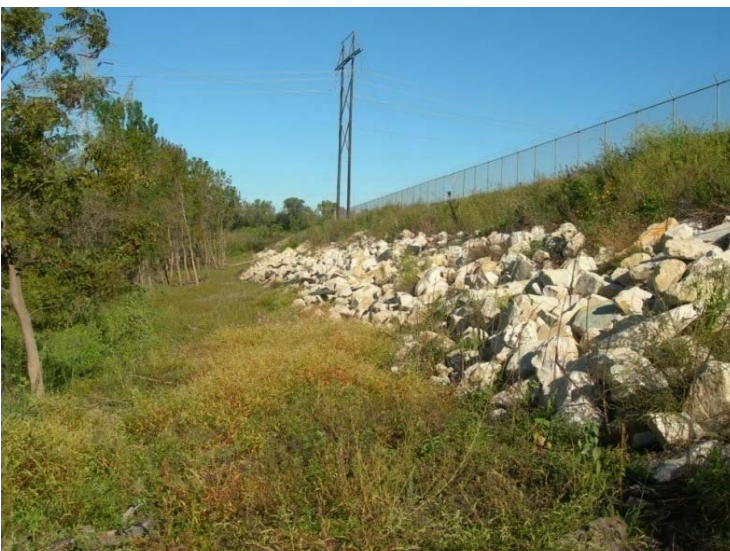
**33A. Looking Northwest at toe of embankment.**

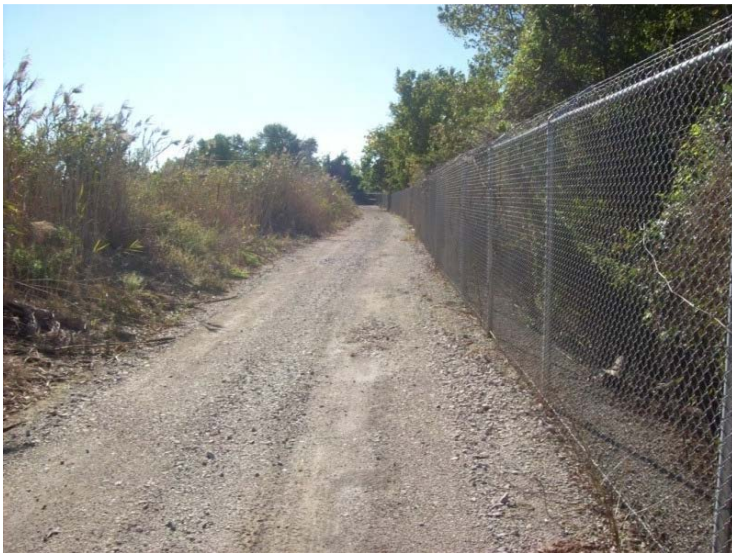
**34. Looking East along top of embankment. Note - area not considered part of embankment see photo 36.**

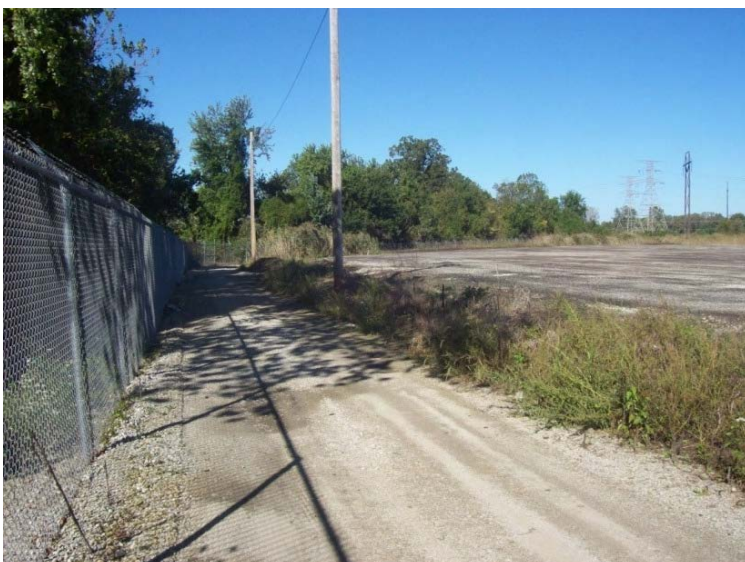
**36. Looking West along access road and top of embankment. Note - area not considered part of embankment.**

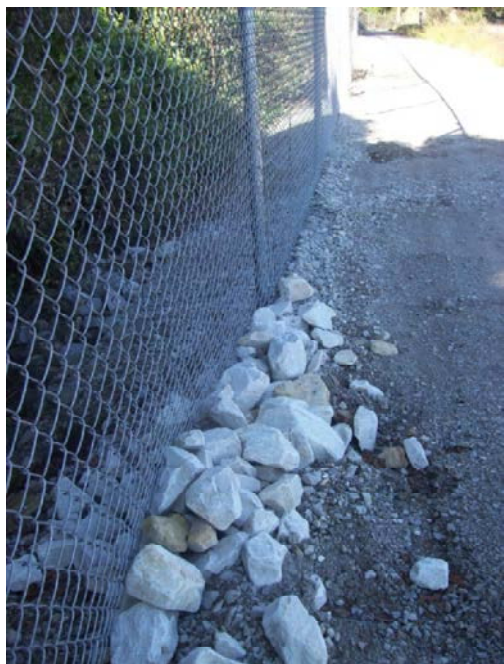
**37. Maintenance of erosion area.**

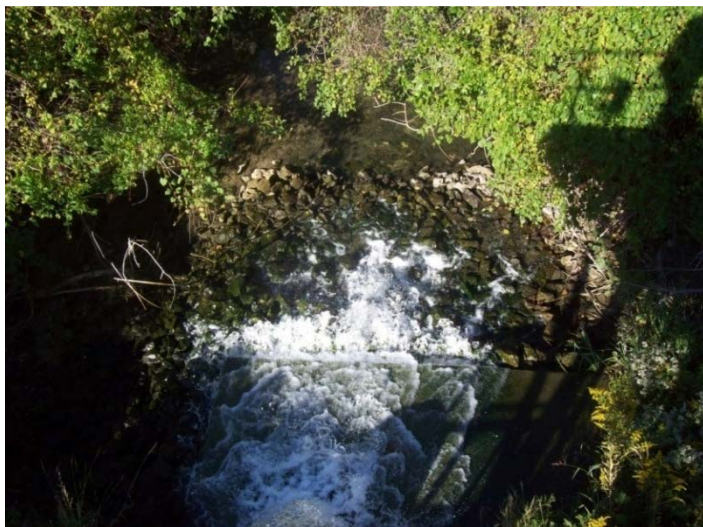
**43. Fly Ash Pond outlet erosion control to reduce velocity.**

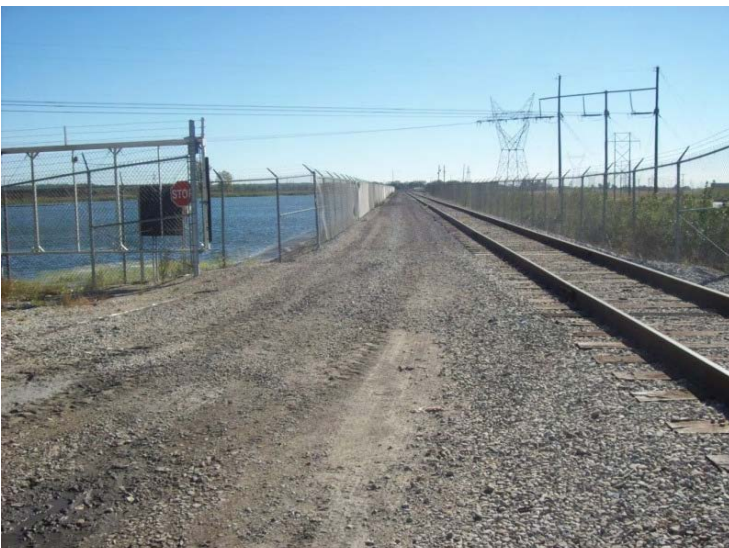
**51. Looking East along top of embankment. Note - railroad used 2-3 times a week for plant use only; 30' wide top width.**

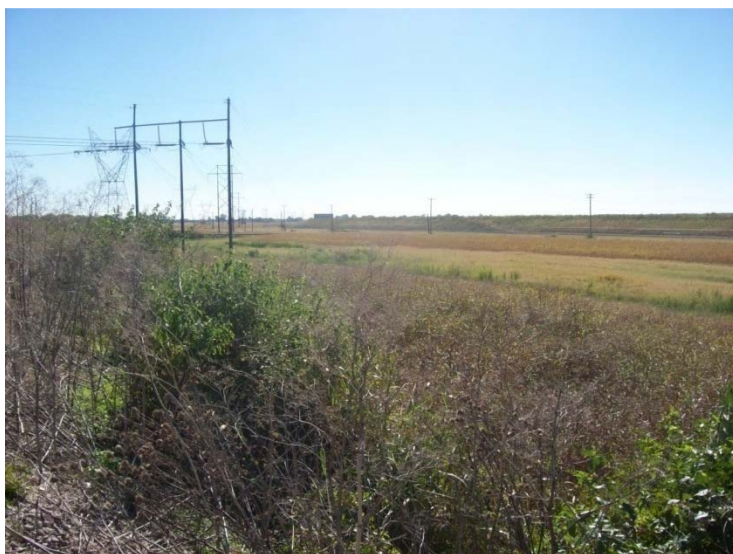
**53. Looking at low wetland area and channel adjacent to toe of embankment.**

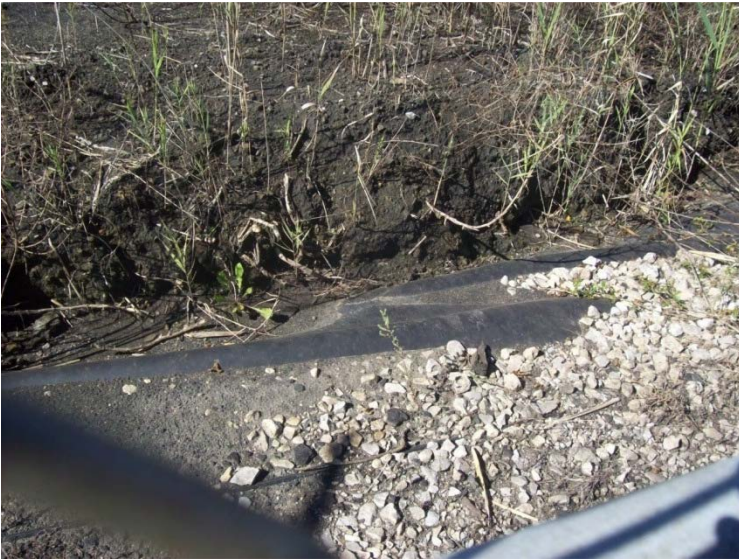
**64. Looking at liner under fill material (Fly Ash).**

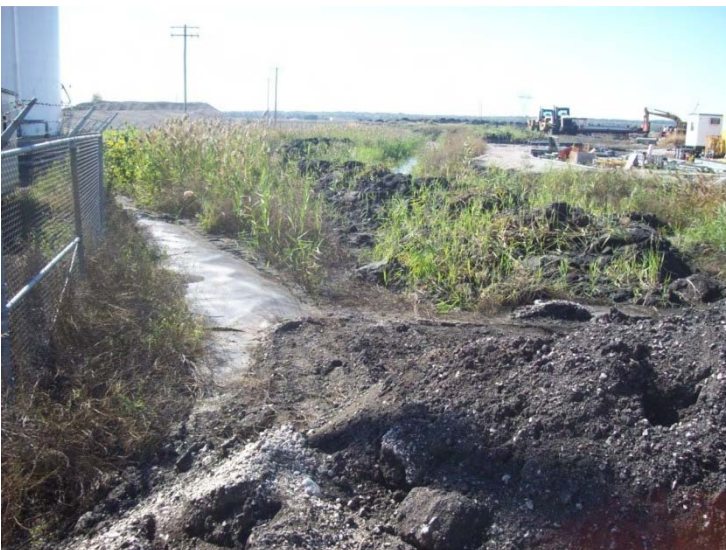
**66. Looking South at channel in fill area. Note - channel flowing into pool area.**

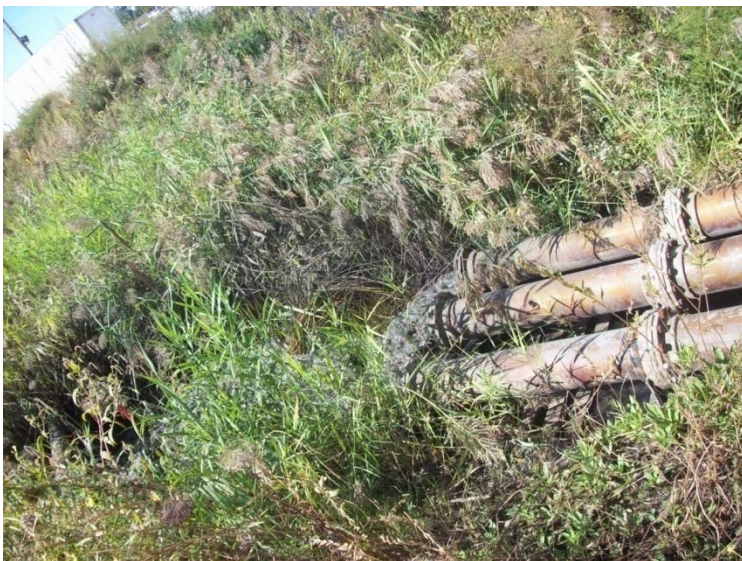
**68. Outfall pipes.**
